WAR DEPARTMENT
U. S. ARMY AIR FORCES
REPORT OF AIRCRAFT ACCIDENT

(1) Place AAF, Lake Charles, La. (2) Date 23 October 1943 (3) Time 1155 CWT
 AIRCRAFT: (4) Type and model A-20G-15 (5) A. F. No. 42-54148V (6) Station AAF, Lake Charles, La.
 Organization: (7) 3rd Bomber Comd. (8) 416th Bomb. (9) 669th Bomb.
 (Command and Air Force) (Group) (Squadron)

(56) Nature of accident Left main landing gear collapsed. 219

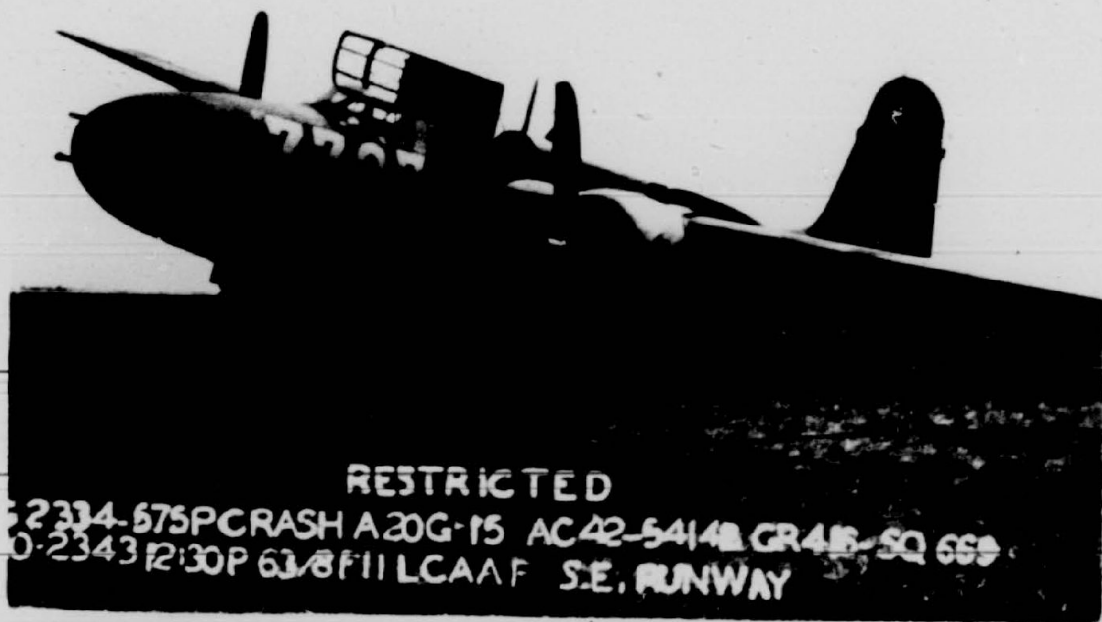
62334-675PCRASH A20G-15 AC42-54148 GR415-SQ 668
10-2343 12:30P 6/8/51 LCAA F SE. RUNWAY

On examination, the left main landing gear retracting arm fitting was found to have the rear portion broken off, and end of the piston of the left main landing gear actuating cylinder was broken off.

1. The fitting of the main landing gear retracting arm was possibly bent, which did not allow the left main gear to completely lock down, and this fitting and the end of the actuating cylinder piston was broken off in landing, as the hydraulic pressure attempted to hold the left main gear down. In arriving at this conclusion, it is presumed that the green light was not actually on, and that the landing gear indicator was wrong in showing the gear down and locked.

1. That more complete preflight inspections be made.
2. That pilots check various mechanisms more completely when indicated, though after so long a time, these procedures seem to become unnecessary.
