1-19-45

45-12-18-521

REPORT OF AIRCRAFT ACCIDENT

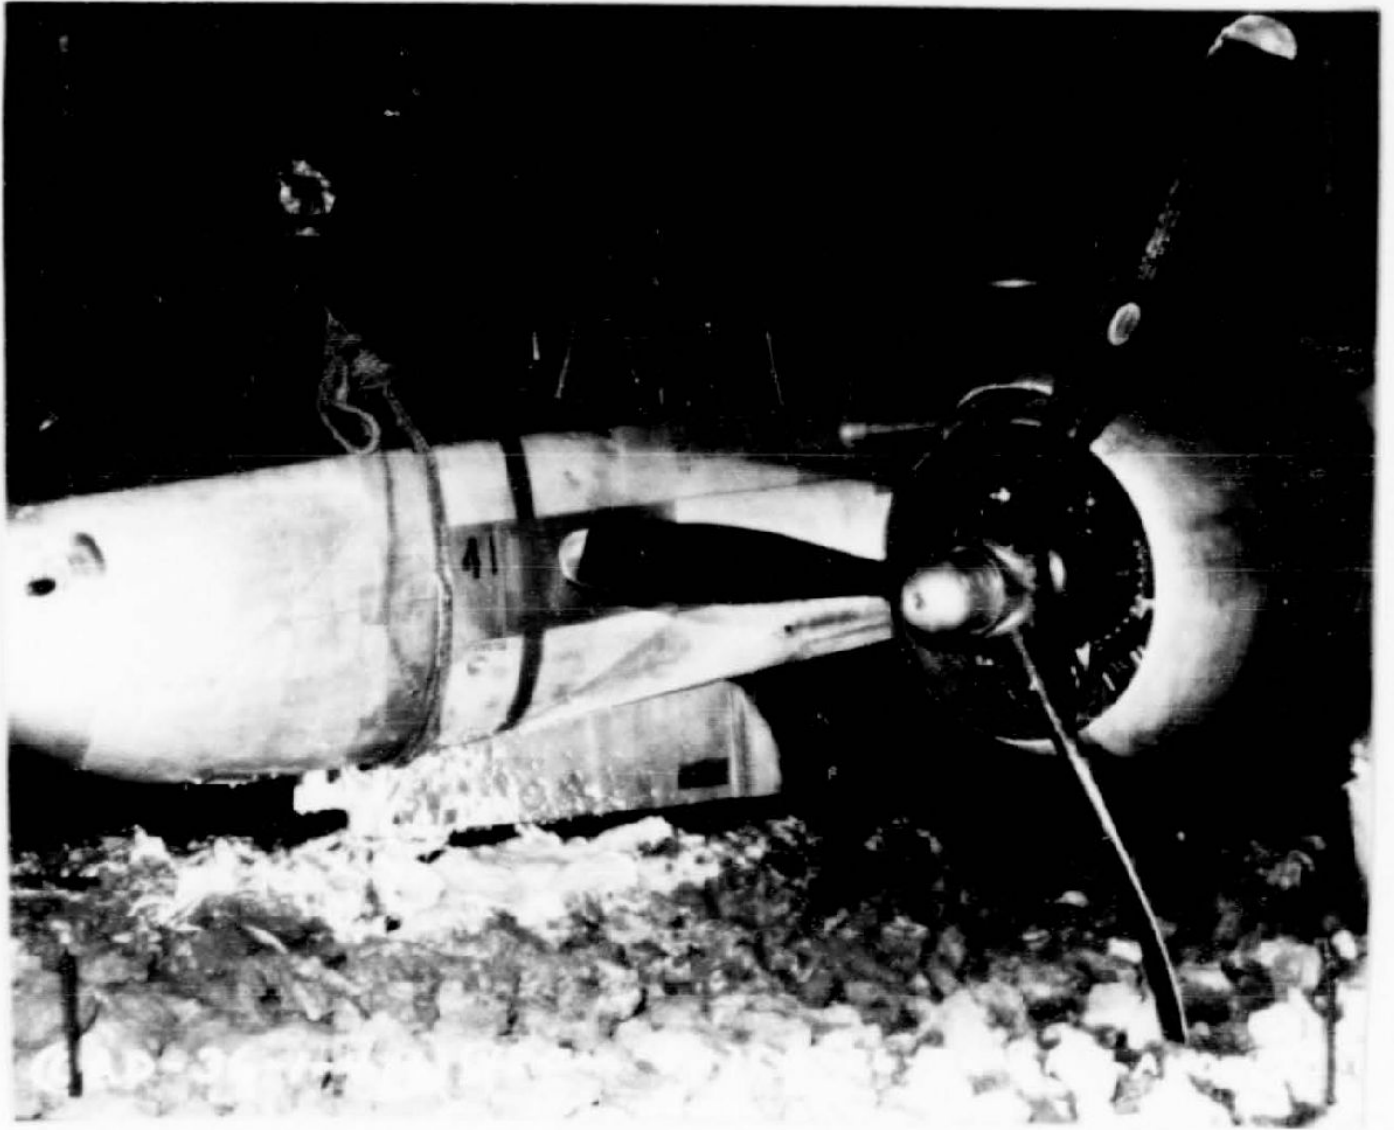
At 2140, 18 December 1944, Lt. Willard made a landing in aircraft A-26B, number 43-22292. He had been recalled because of enemy intruders. There was no time to change the direction of landing. Consequently, the landing was made on a wet runway, in a light ground fog, with a slight tail wind of 5-6 miles per hour. The aircraft was landed approximately 20-25 M.P.H. faster than the normal landing speed of the A-26. Consequently, when the pilot attempted to stop he skidded off the end of the wet runway. The runway shoulder was unservicable because of a soft, filled bomb crater. Consequently, the nose wheel bogged down, both propellers were bent, and the left engine sustained sudden stoppage.

- 50 percent - Airfield conditions - Wet runway and unservicable shoulder.
- 20 percent - Pilot error - Error in technique. Although he had been warned that he was landing slightly downwind, Lt. Willard landed faster than normal. Also, he did not cut the mixture control to make use of the breaking force of the windmilling propellers.
- 10 percent - Weather - Poor ground visibility.
- 20 percent - Handling qualities - This aircraft has pronounced tendencies to veer and skid, and is exceedingly difficult to stop on a wet runway.

Pilots should be cautioned to land as slowly as possible when a downwind landing is necessary.
