WAR DEPARTMENT
U. S. ARMY AIR FORCES
REPORT OF AIRCRAFT ACCIDENT

(1) Place Keesler Field, Mississippi (2) Date 26 November 1943 (3) Time 1900 CWT
 AIRCRAFT: (4) Type and model A-20G-20 (5) A. F. No. 286692 (6) Station DS, Miss.
 Organization: (7) 3 Bomb Com-III AF (8) 416 Light Bomb (9) 670 Light Bomb LAUREL
 (Command and Air Force) (Group) (Squadron)

(56) Nature of accident Miscellaneous. Collision after jumping chocks and swerving into a plane which was parked adjacent to it.

(57) Cause of accident Apparent inability of crewmen to definitely determine whether parking brakes were fully applied and throttle in a near closed setting before starting engines on an unlighted portion of airrome during hours of darkness.

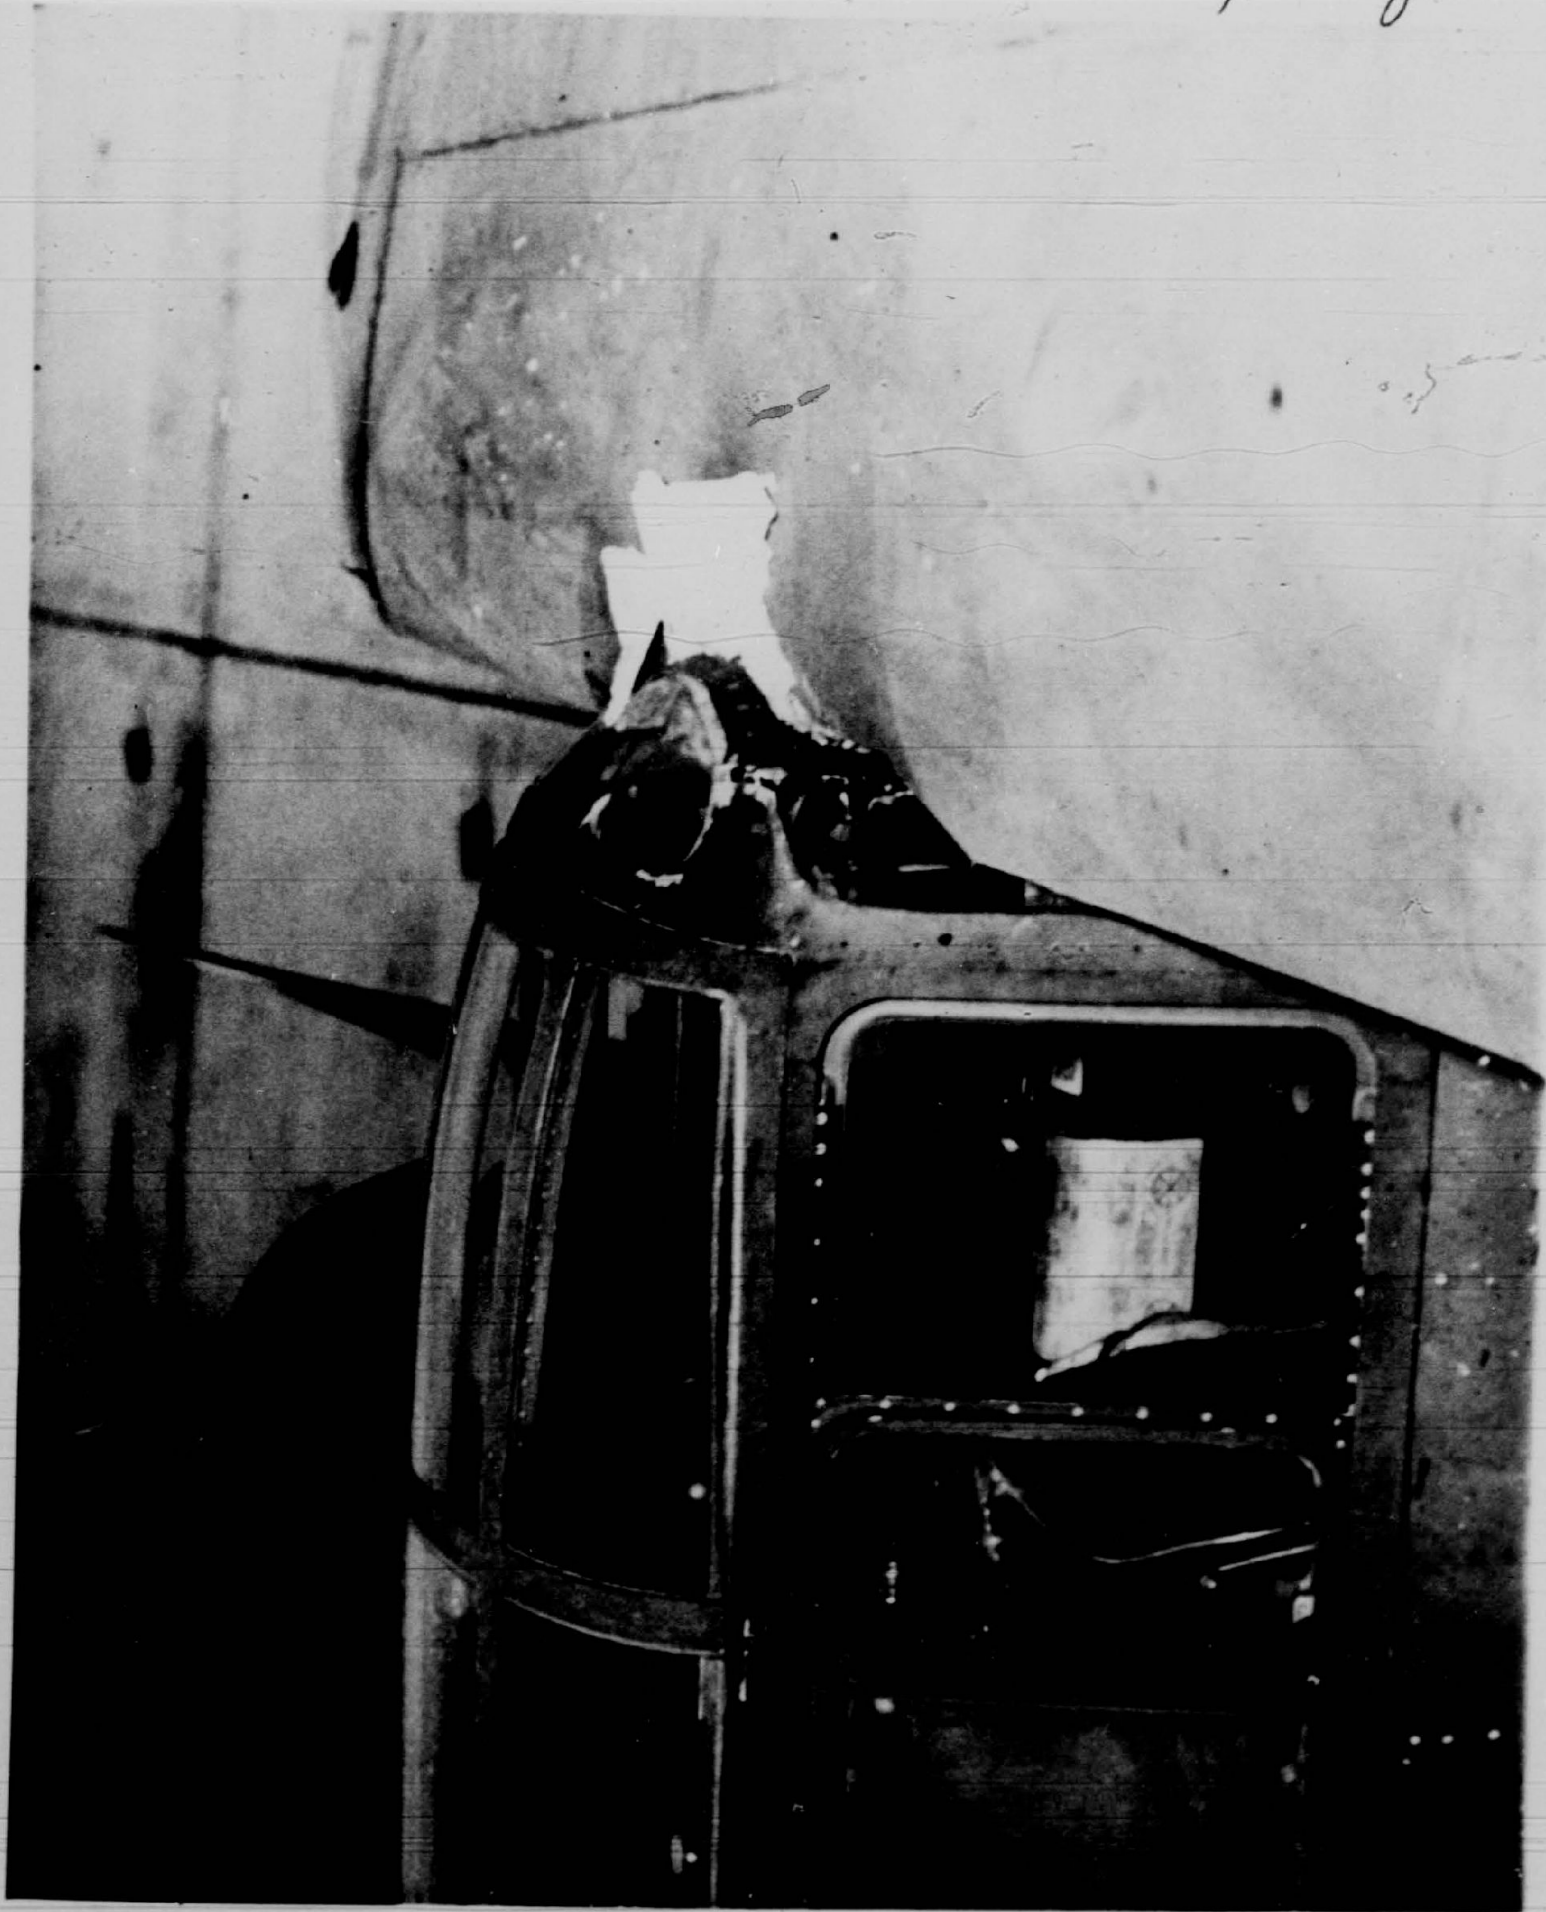
DAMAGE	(49) LIST OF DAMAGED PARTS
(46) Aircraft <u>Major</u>	<u>Extensive damage to right outer wing panel; extensive damage to windshield assy; moderate damage to nose section.</u>
(47) Engine(s) <u>None</u>	
(48) Propeller(s) <u>None</u>

- Incl 1 - WD AAF Form #14 re A-20G-20, AC serial #286624.
- Incl 2 - WD AAF Form #14 re A-20G-20, AC serial #286582.
- Incl 3 - Statement of Crewman charged with accident.
- Incl 4 - Close-up of wing panel and nose section.
- Incl 5 - Close-up of two damaged airplanes.
- Incls 6 & 7 - Interior views of two cockpits.
