WAR DEPARTMENT
U. S. ARMY AIR FORCES
Hunter Field, Georgia
REPORT OF AIRCRAFT ACCIDENT

43-057

(1) Place Hunter Field, Georgia (2) Date 30 August 1944 (3) Time 1154 4
AIRCRAFT: (4) Type and model A-20K-15-DOO 29 (5) A. F. No. 44-563 (6) Station Hunter Field, Georgia
Organization: (7) 3AFSW (8) _____ (9) _____
(Command and Air Force) (Group) (Squadron)

SUBJECT: Landing Accident of Aircraft A-20K, Serial No. 44-563.

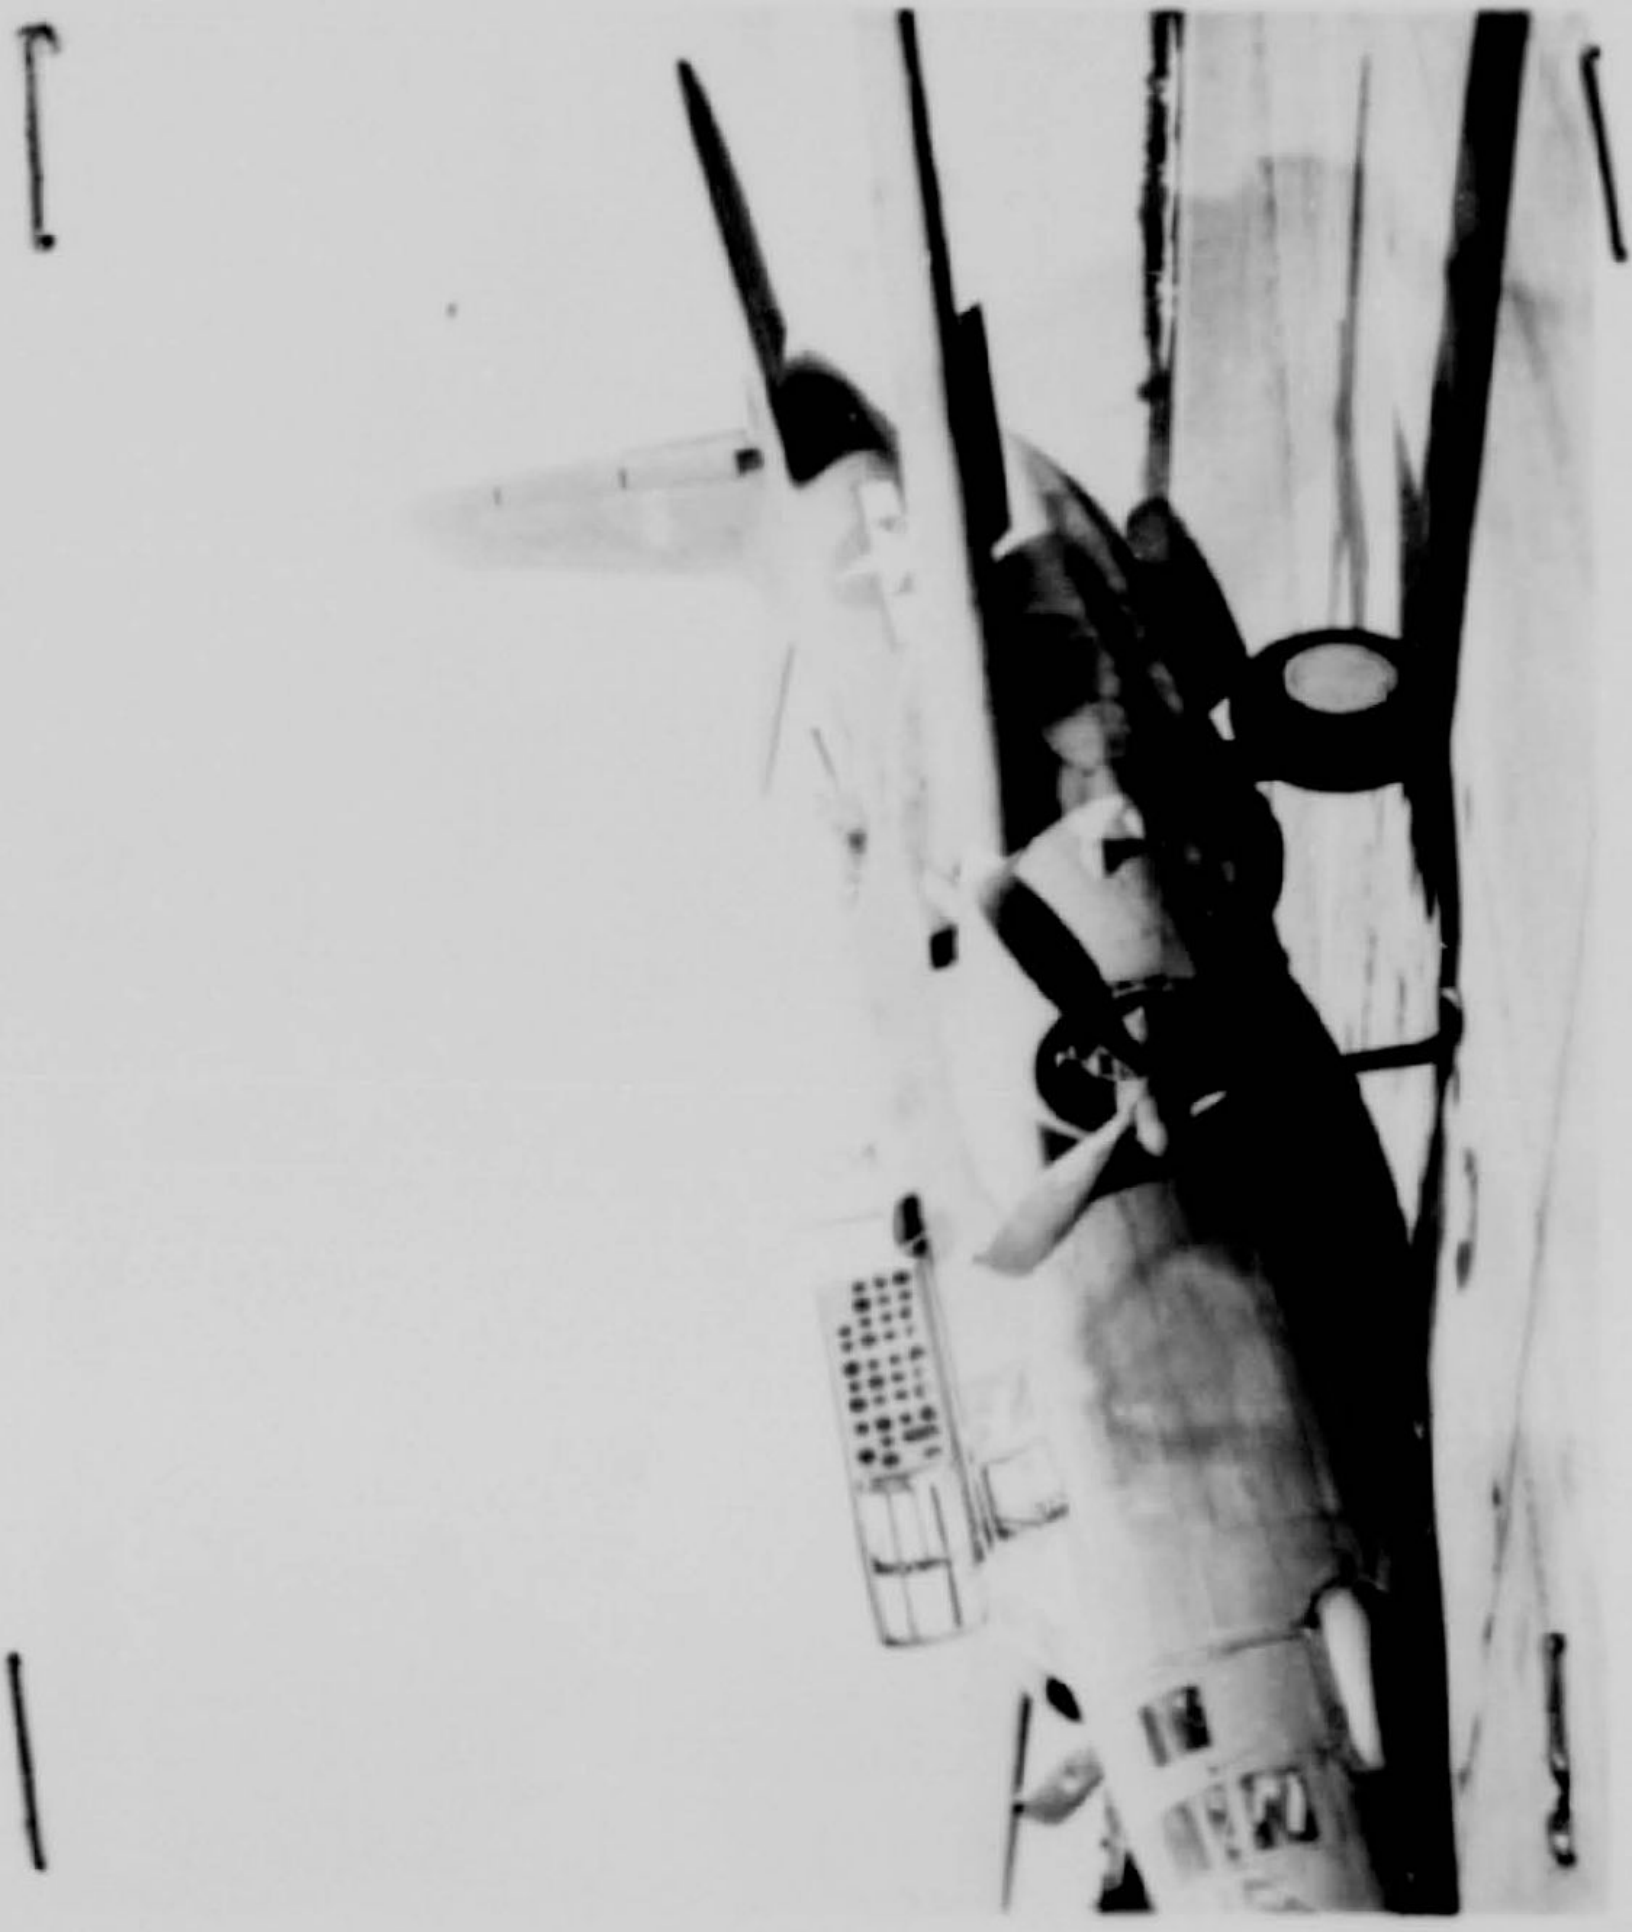
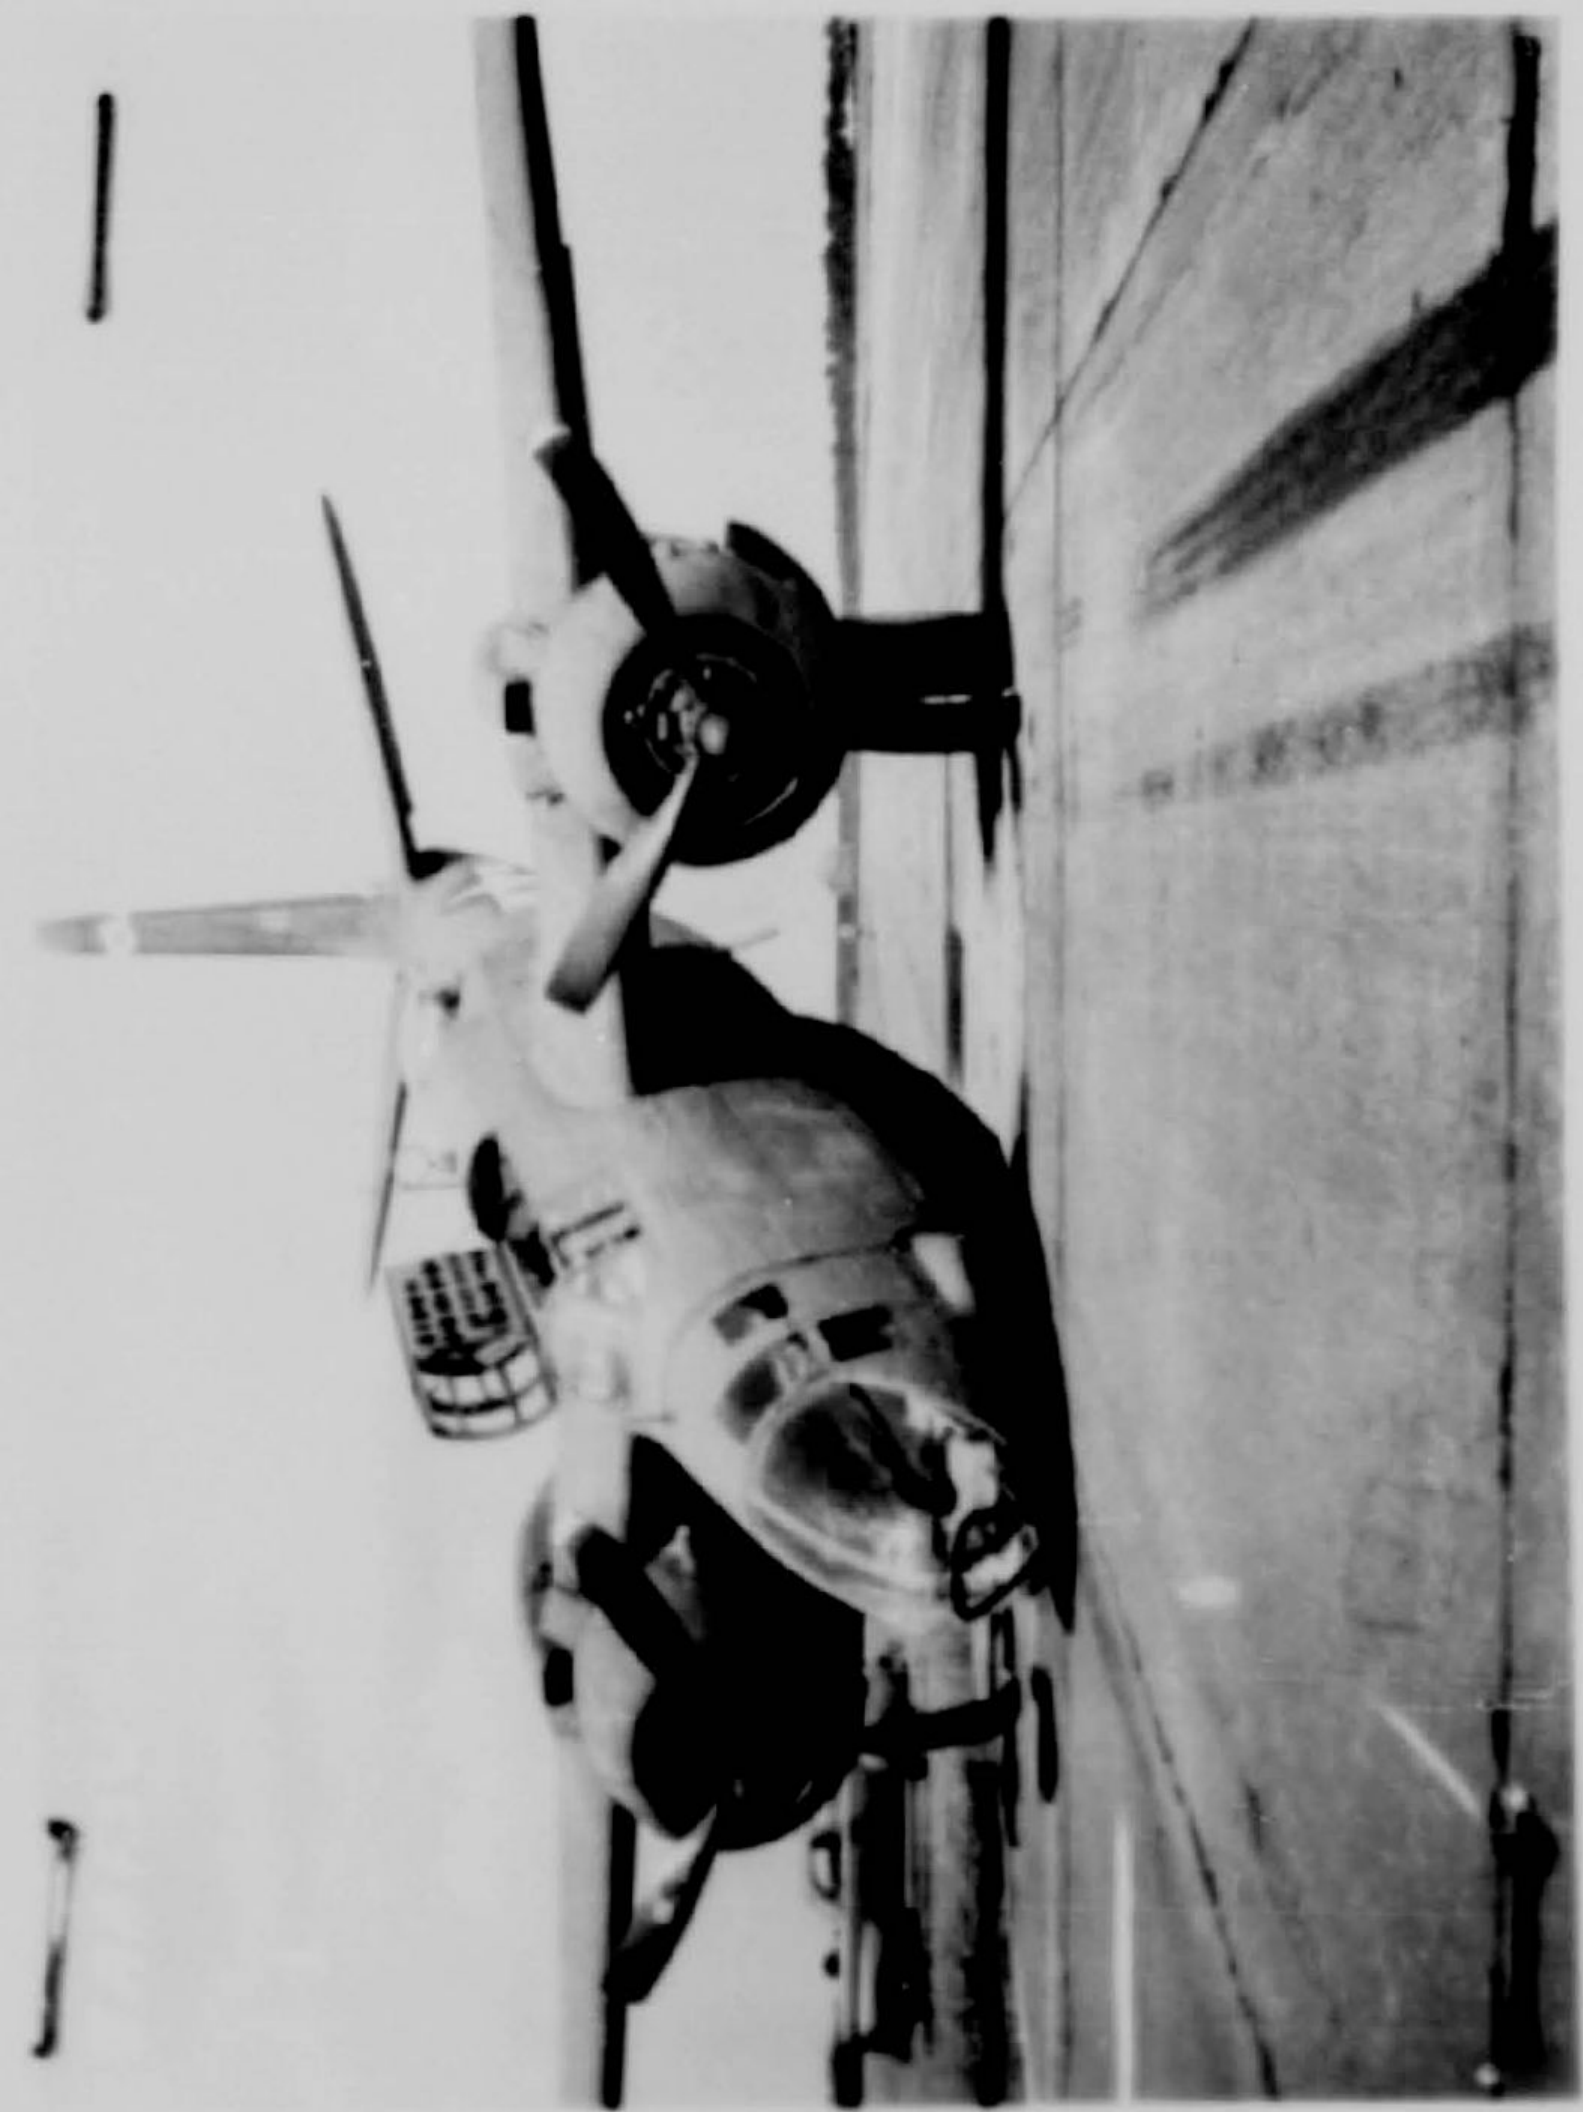
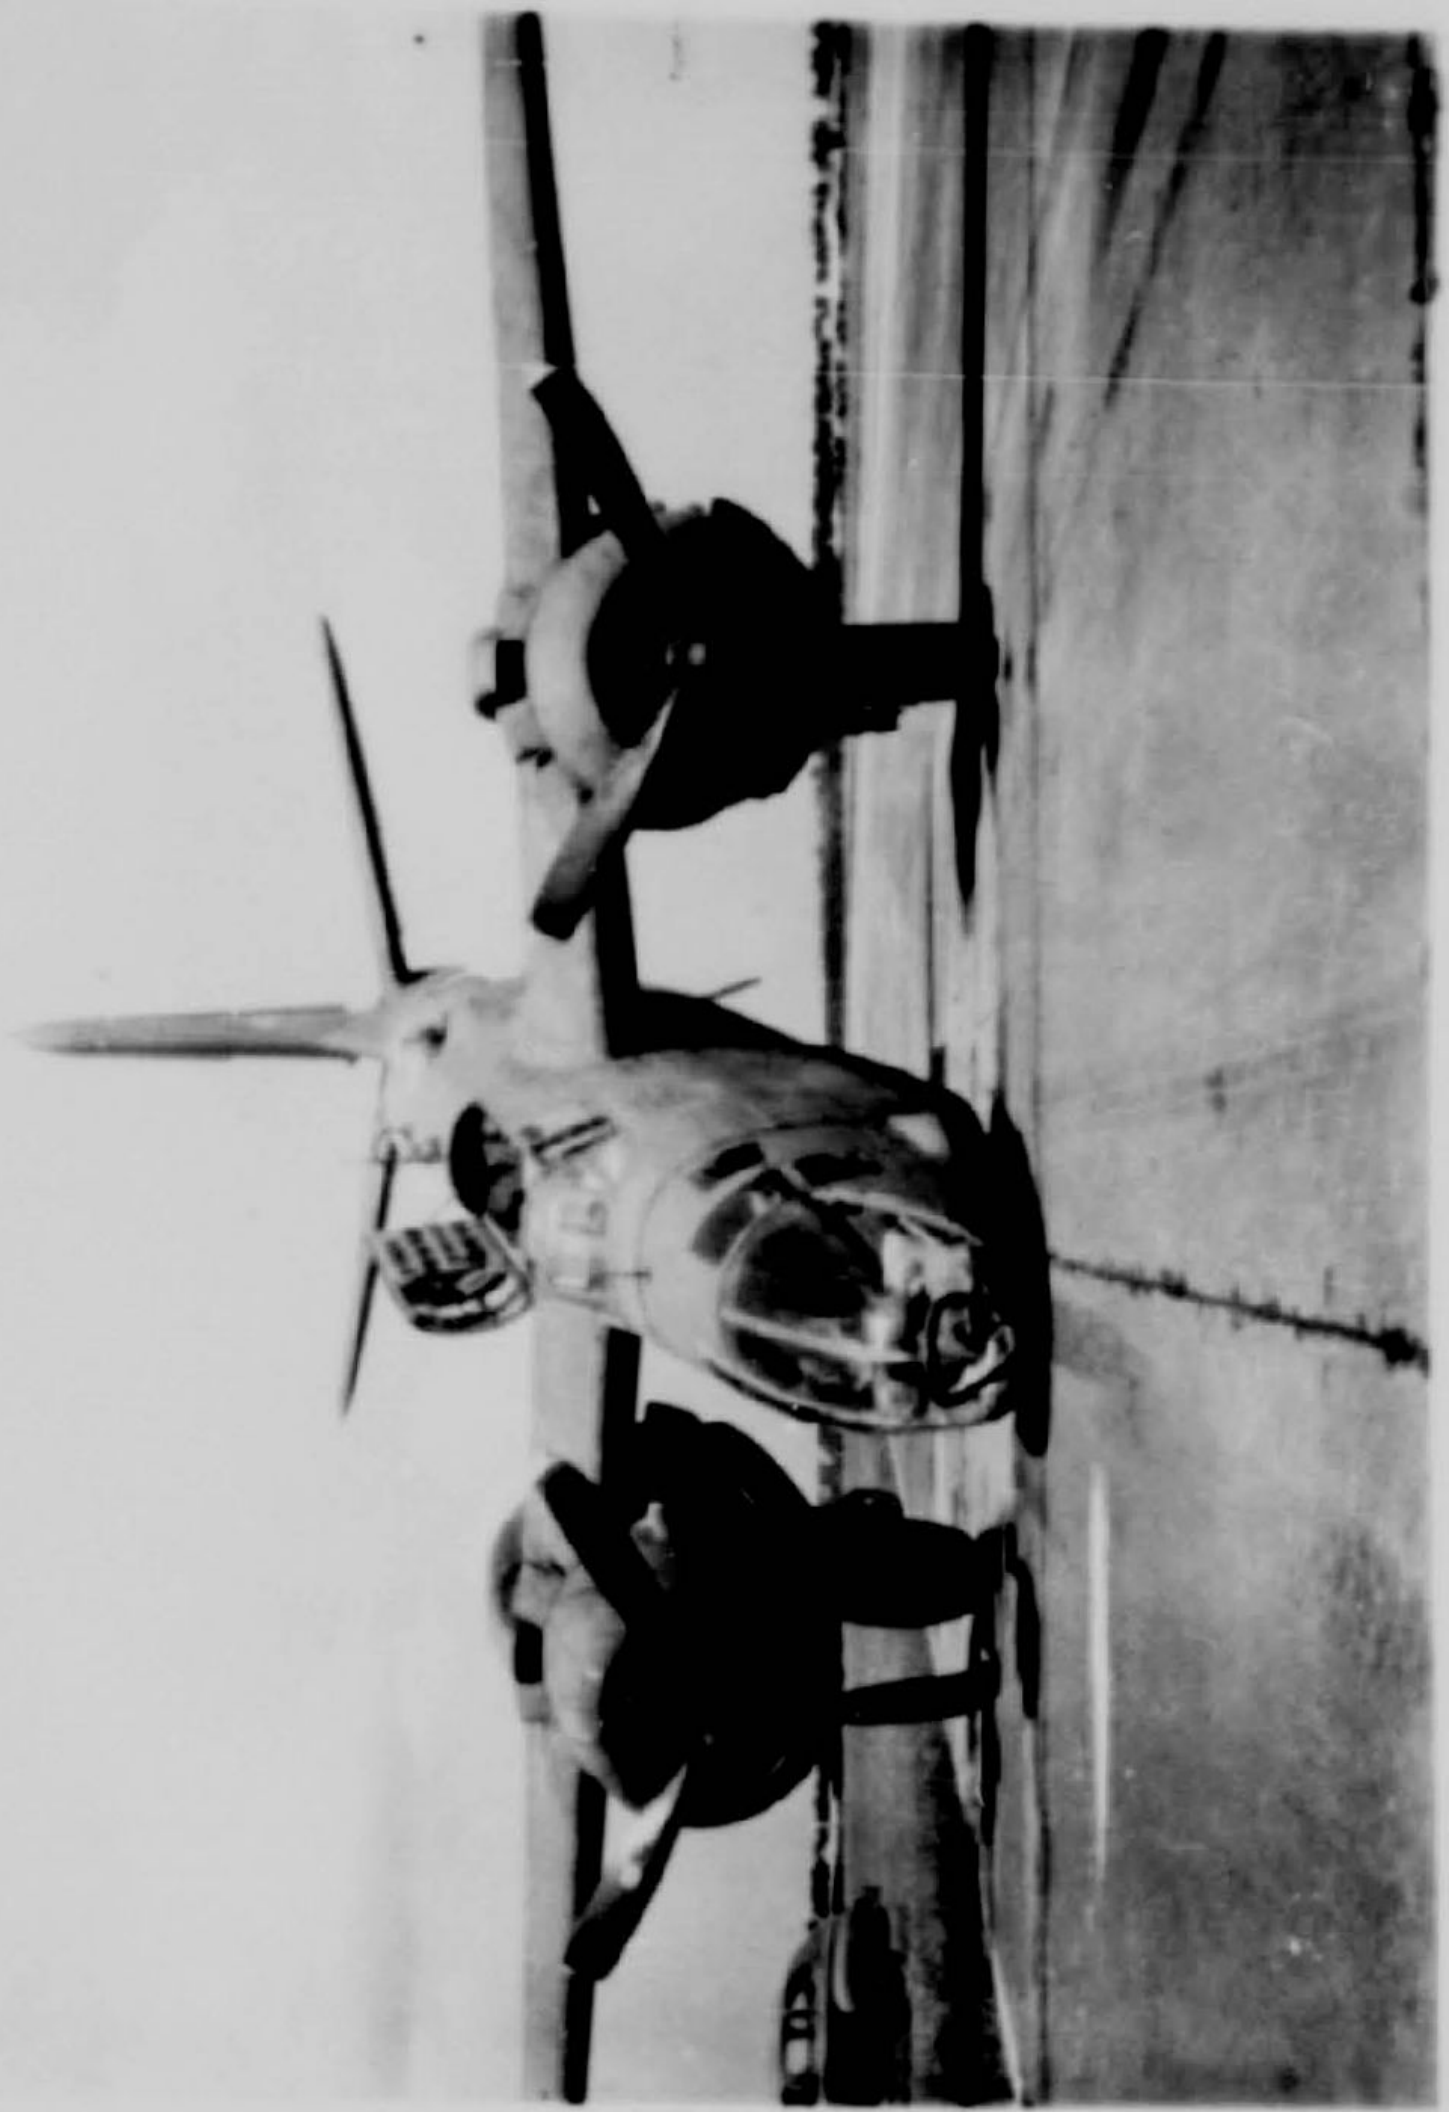
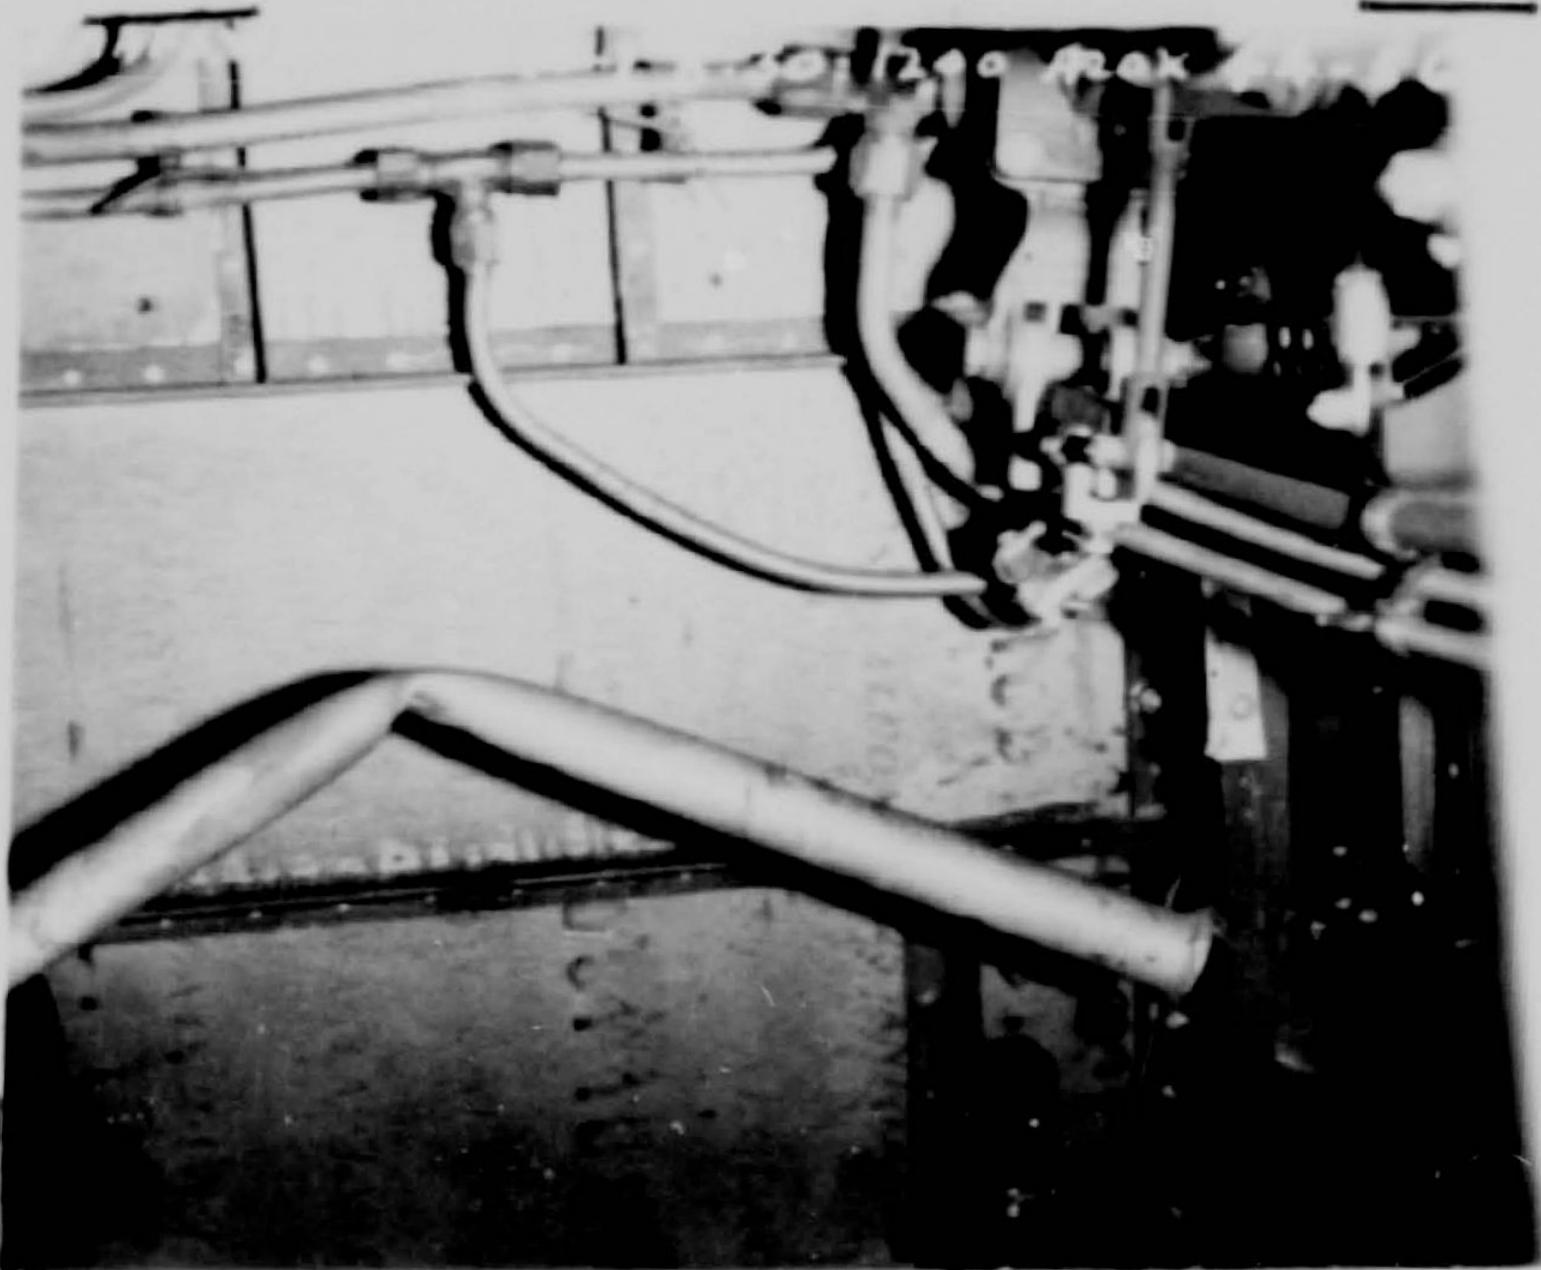
DAMAGE	(46) LIST OF DAMAGED PARTS
(46) Aircraft <u>3</u>	Engines, propellers, nose wheel strut, nose section of fuselage.
(47) Engine(s) <u>04 4</u>	
(48) Propeller(s) <u>W2 4</u>

(56) Nature of accident Nose wheel, upon landing, was not in down and locked position causing the nose of the subject aircraft to come in contact with the runway when control speed of the aircraft was lost. *06*

(57) Cause of accident The nose wheel actuating structure was damaged when pilot attempted to retract landing gear while the down position locks were still in place.

3. Failure of Nose wheel ground lock permitted partial retraction of Nose wheel. At this point the broken lock caused the retracting gear to jam. The actuating cylinder was torn loose from its mounts, thereby making it impossible to return the Nose gear to the down and lock position.
